Service Completion Certificate
C-403, Corporate Avenue Andheri Ghatkopar Link Rd, Andheri (E), Mumbai-400093.

Subject : Breakdown (out warranty)

Subject : Out Warranty AC (Breakdown) Sr.No.

User Name : City Union Bank.

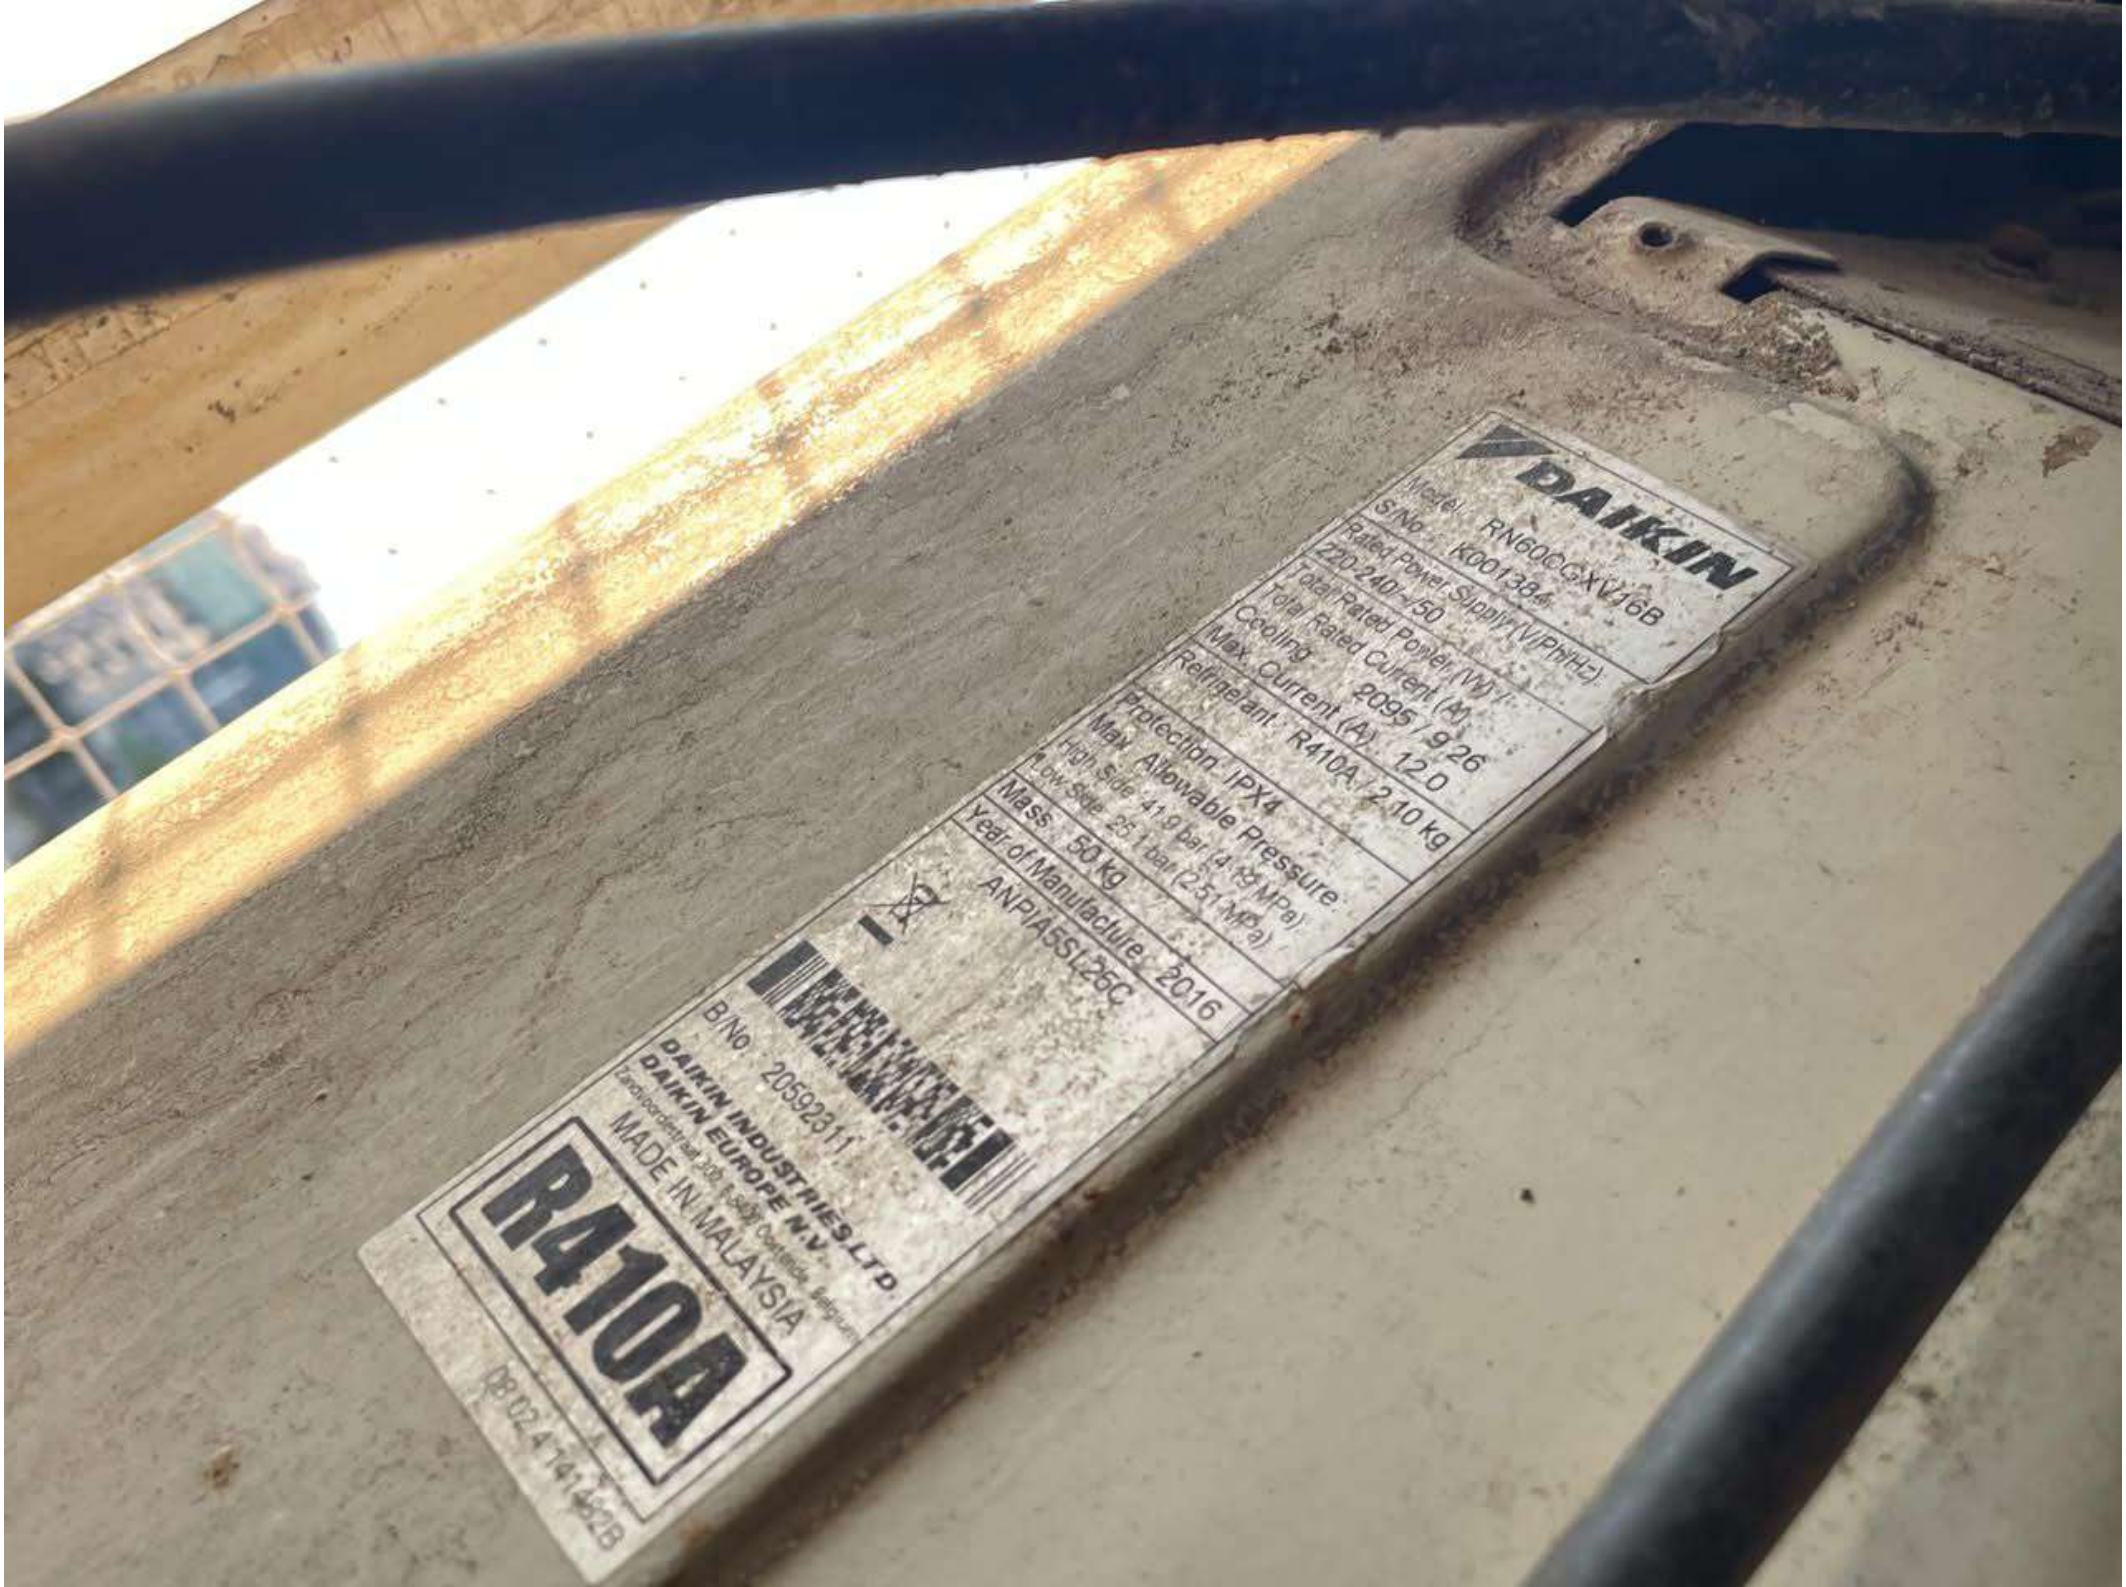
Work Date	No. of S.E.	Work Hours	Progress Code	Details of the Repair Work
07		3:00		Cassette ACs → (2 Nos aging 10 yrs)
11		PM		Condenser coil of ODU is damaged.
26		4:00		Rusting problem. Need to replace both the ACs

Service Engineer Remarks
Suggestion of replacing ACs both cassette
Site visit Charges pending
